# **Inspections - Section 11**

## **New Construction Case Study**

Four Story Motel finished 12/98 - inspection 5/26/99

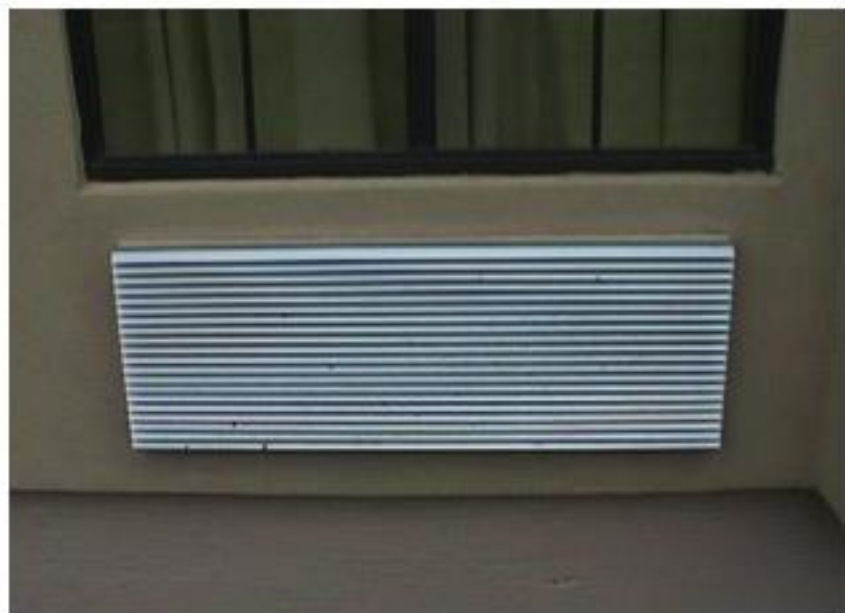
- No sealant on any window
- Sealant around A/C units “smeared” without backwrapping
- Significant water found at perimeters of most windows

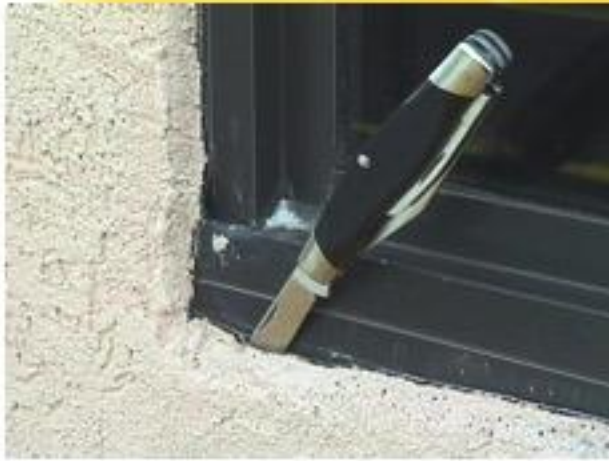
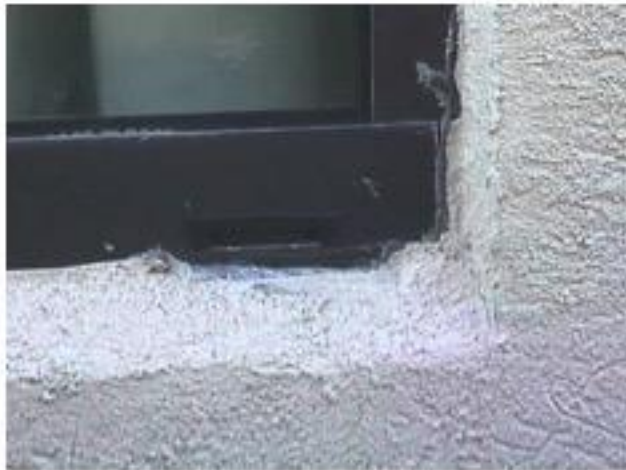
- Knife slides in between plastic and window frame
- Plastic wrapped on to frame and plaster applied on to the plastic
- The plane between the plastic and the window frame allows water to enter easily
- Note on lower photo that the plaster was blocking the weep holes by approximately 3/16"

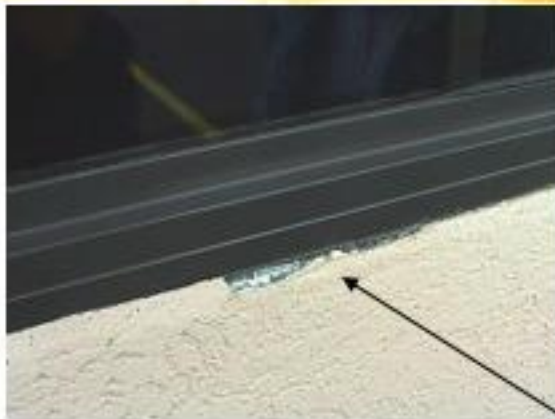
Sill material cut away exposing insulation, fabric and leaving a hole allowing water to enter

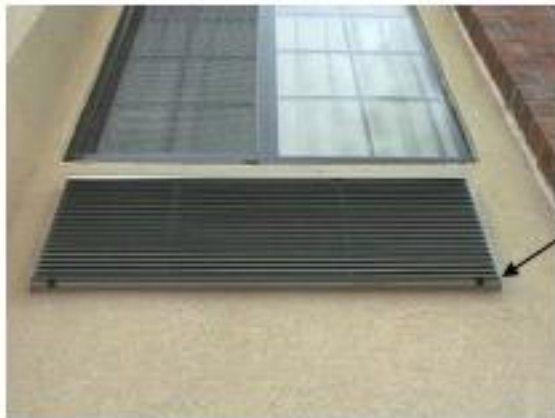
A/C sleeves set to allow drainage to outside of wall. Sealant will fail

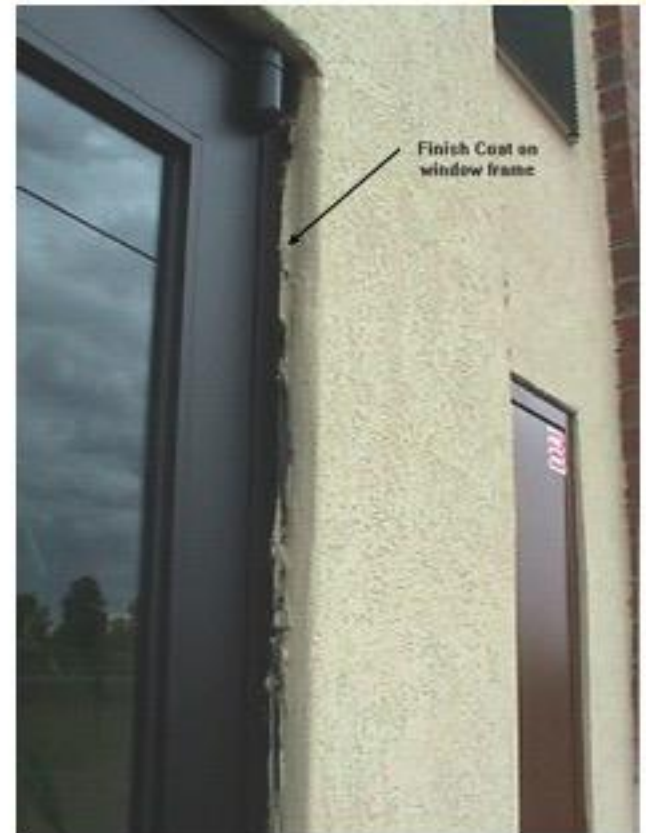
Plaster sloppy - lumps, plaster on aluminum frame

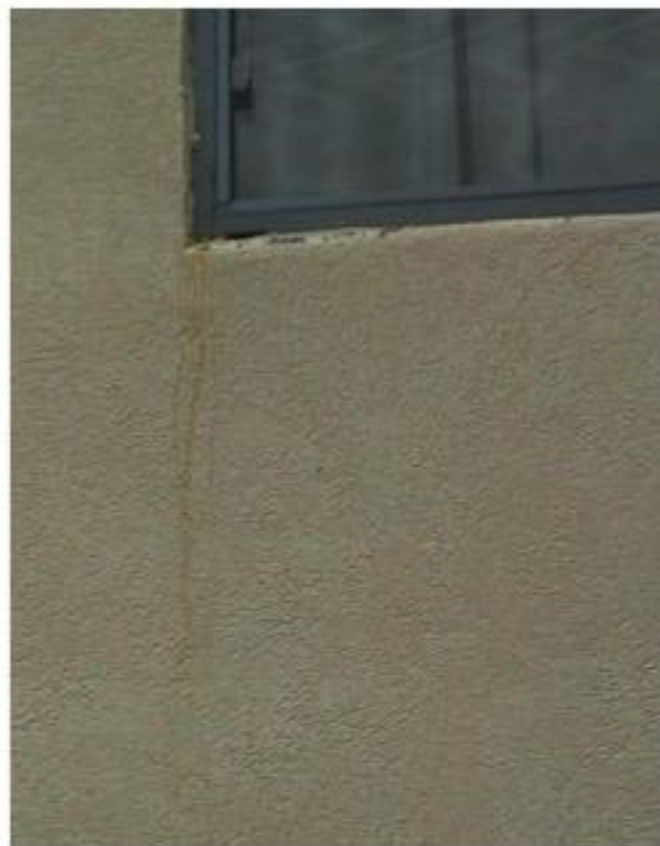
- See staining at jamb line at sill.
- This color indicates that the wood framing is adding sap to the staining
- Indicates water within the frame area of the exterior wall

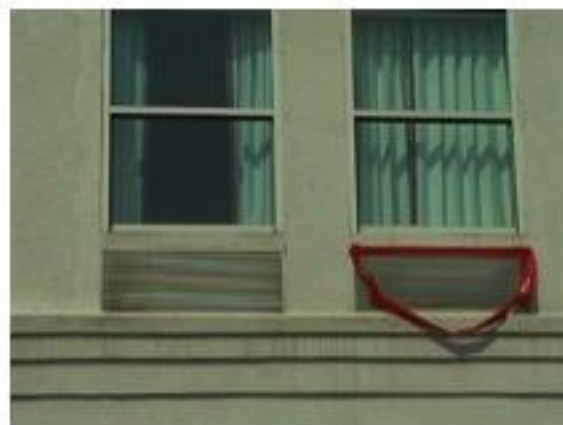
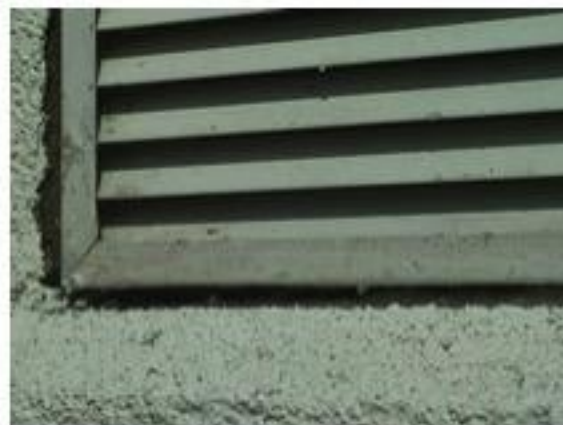
- These A/C sleeves drain at each end through the bottom. The holes go from the face of the sleeve to 1" deep into the wall. There is no room to get backer rod and sealant into the joint back far enough to prevent the water from entering the wall.
- The backwrapping on this job is very rough. Lots of effort that accomplishes nothing.

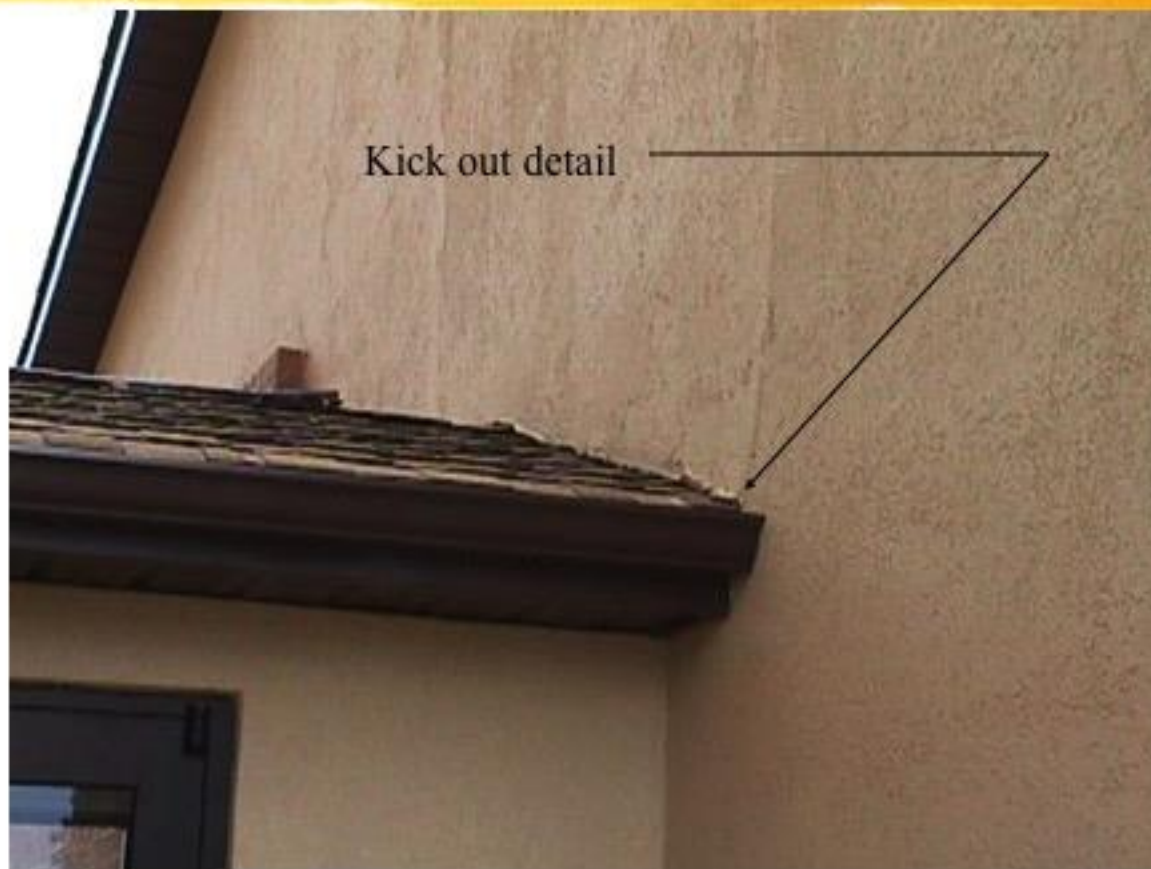
There were 14 separate locations that required kick out details that were not present

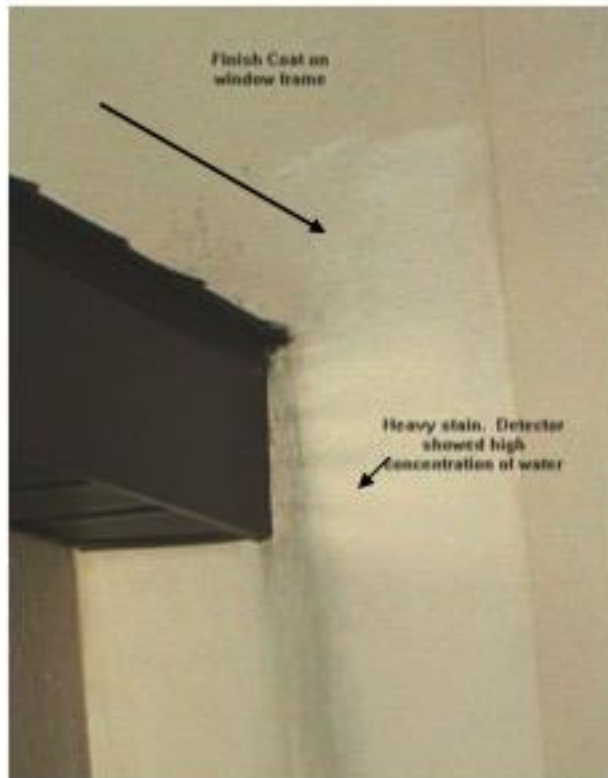
Main roof ending in stair tower wall  
No kickout detail

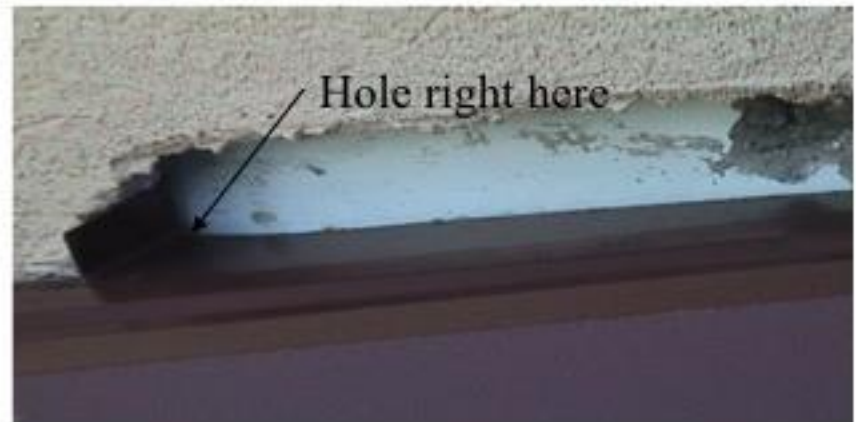
“Mock” kickout at metal roof

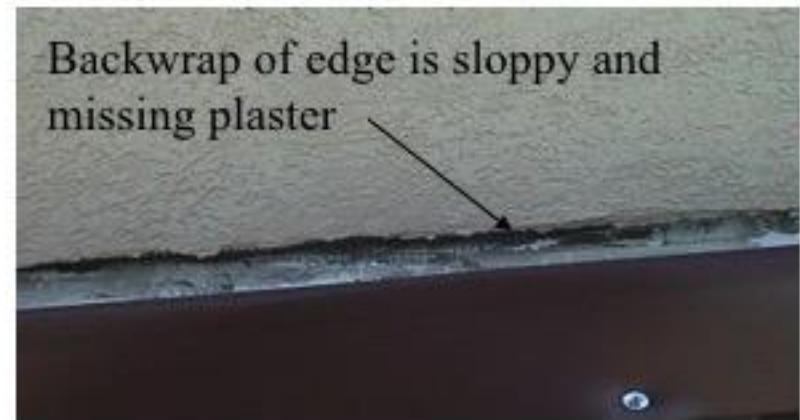
Flashing at metal roof

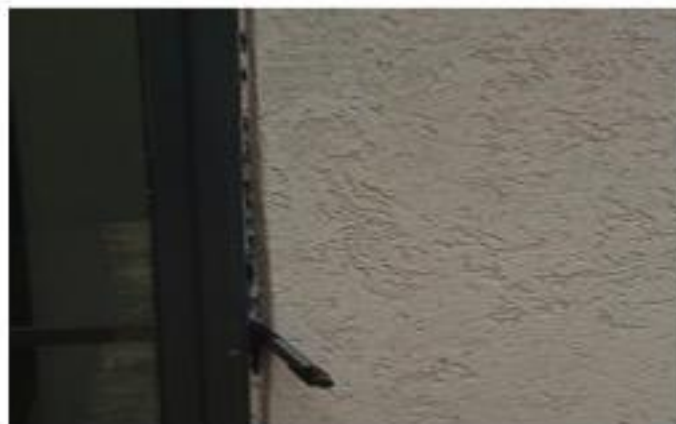
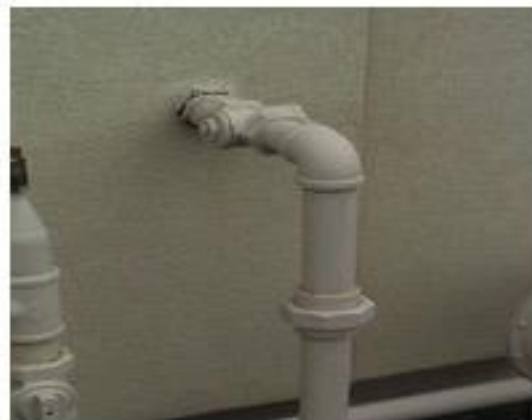
- Top photo shows major gaps in sealant at windows - this is worse than no sealant
- Bottom photo is typical. There is no sealant at small penetrations

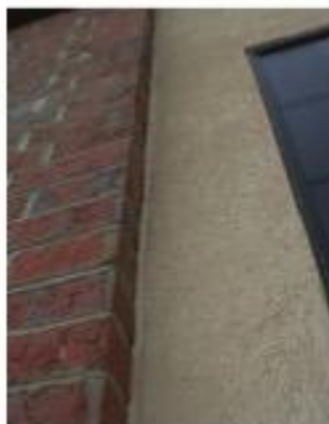
Vertical sealant has many gaps and no bonding to one or the other edge. No primer, no tooling.

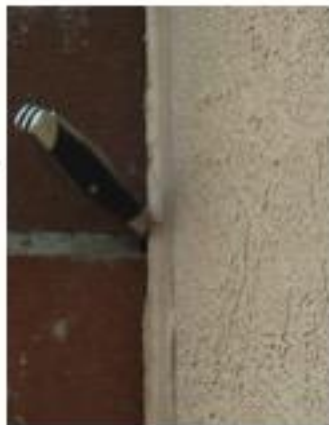
Knife easily slides into gap where sealant not bonded.

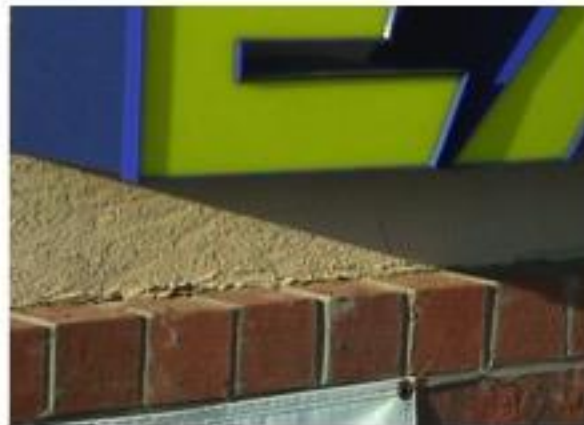
Horizontal sealant not present. No space for backer rod and sealant. This is up high and not easy to inspect.

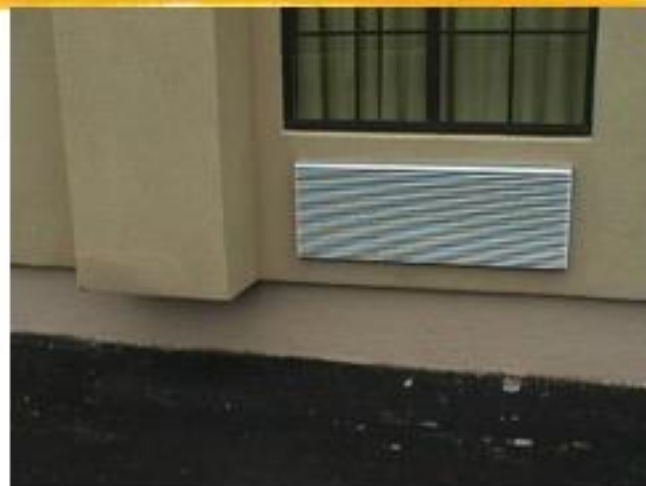
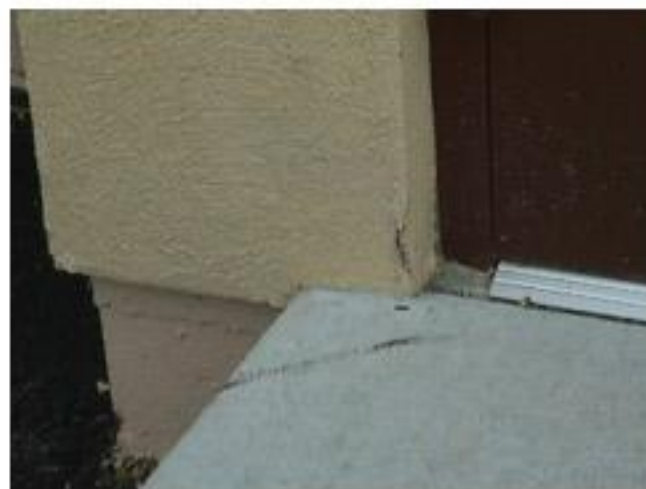
- Top photo shows EIFS held off grade. Check for backwrapping (not on this job)
- Bottom photo shows EIFS tight to sidewalk. This will eventually buckle and spall.

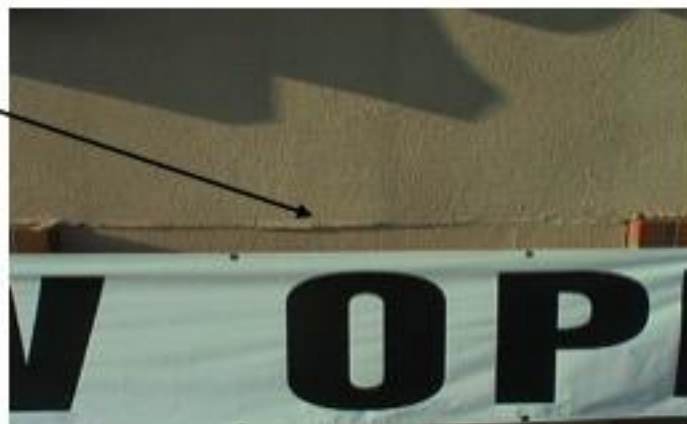
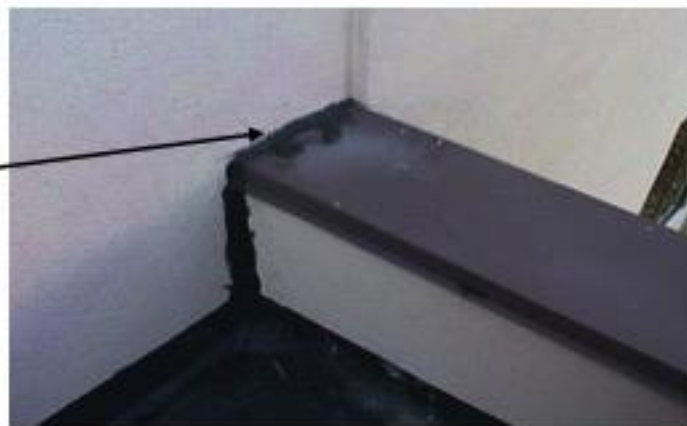
- On end walls at the top of the brick the EIFS was simply discontinued and begun again leaving a line that was “gooped” with some silicone. Hard to find since there was a sign to cover it up.
- This detail is very common. Parapets are simply ended with no counterflashing. The cap flashing is caulked to the wall. This area was very wet all the way to into the roof insulation.
