Retrofit Inspection

Pineville, NC
6 story motel

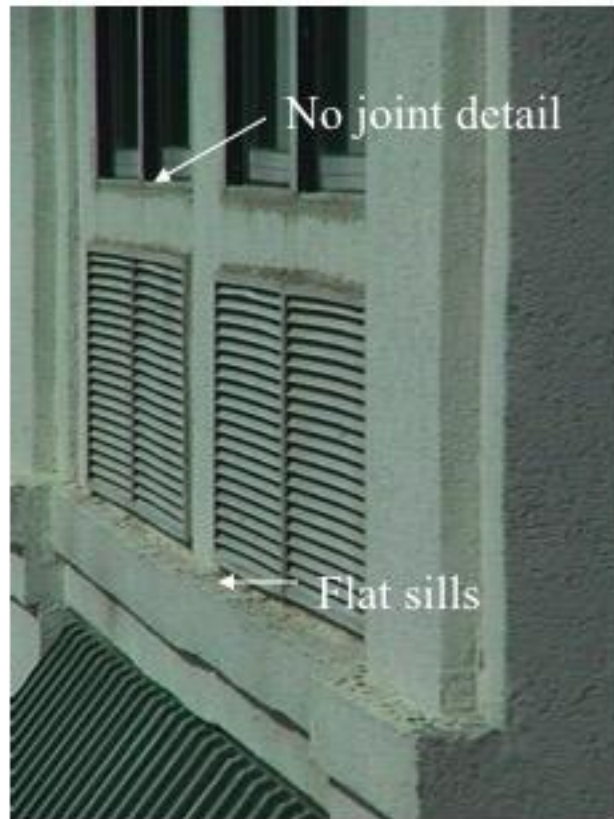
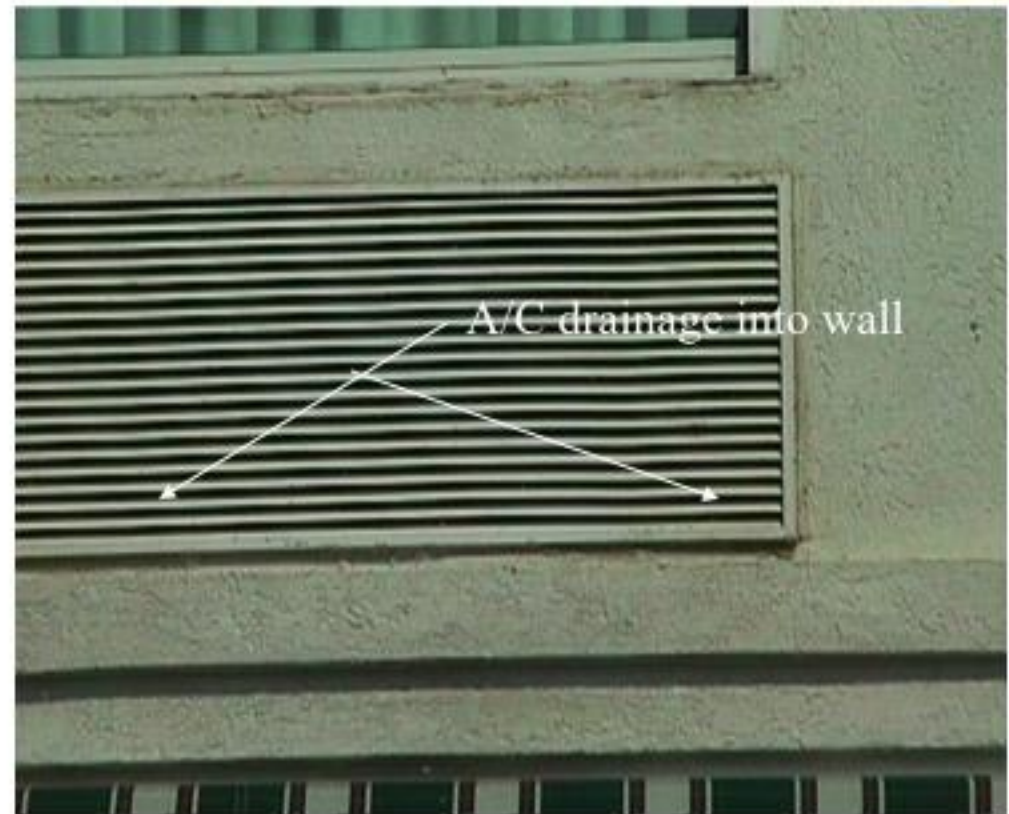
Windows - original condition

Windows had no sealant joints. There were flat sills under the A/C units and the A/C sleeves were draining behind the face of the EIFS.

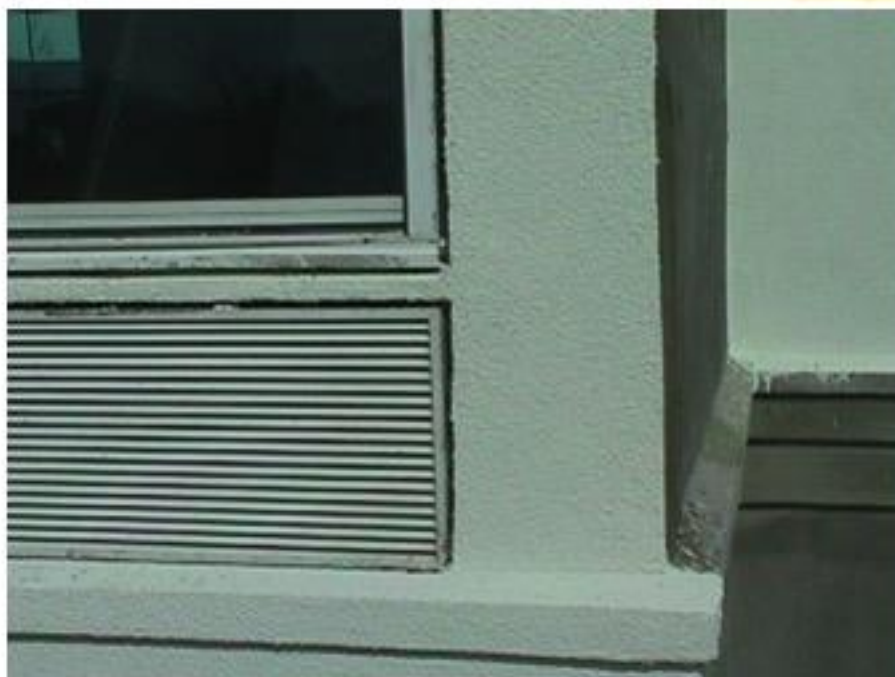
Rebuilt Window & A/C

This finished rebuilt detail took lots of work to accomplish. On the surface the joints now exist and appear to be ready for sealant. There are new Jamsill brand sill flashings in place. The slides that follow highlight the details of the failed workmanship.

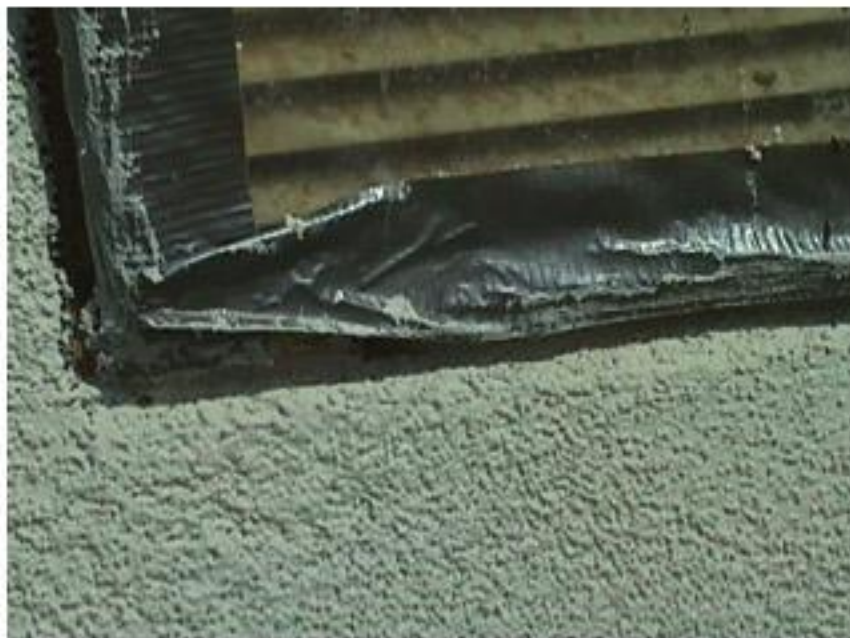
Sealant joints - windows & A/C

Window joints vary in width from closed to open making sealant almost impossible to accomplish correctly

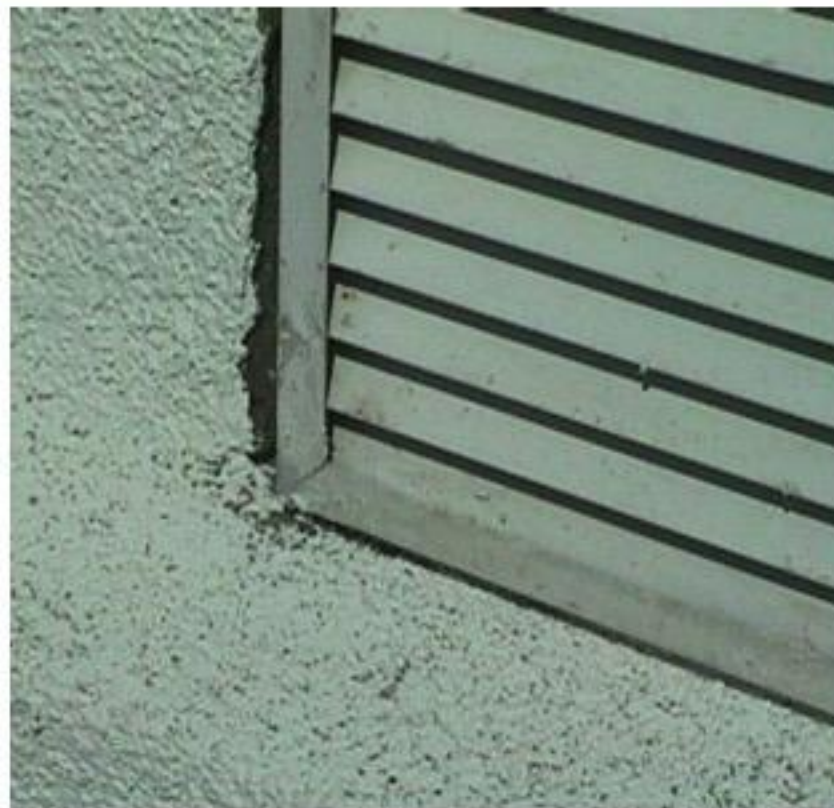
Sloppy finish and filled joint will result in failure in joint sealant

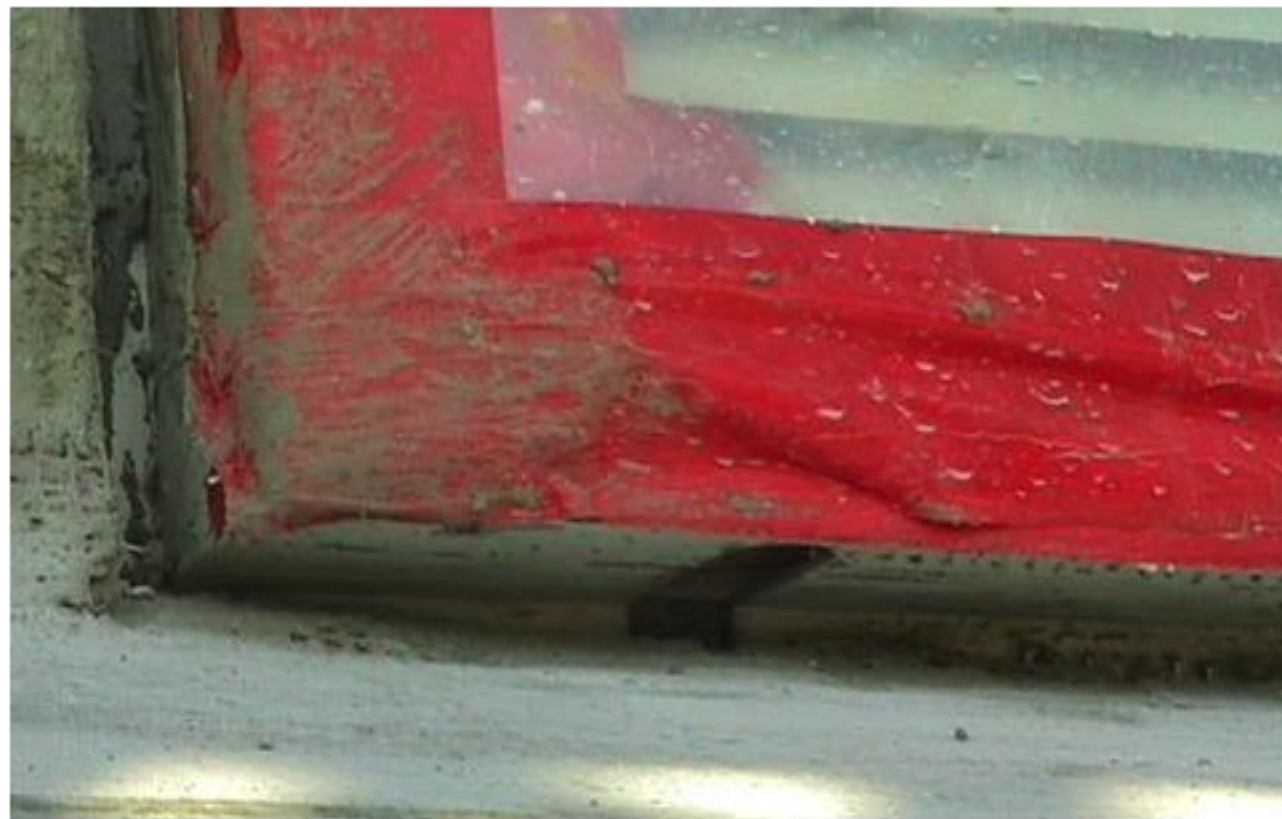
A/C sleeves rebuild

Close up of the weep holes. New flashing is to reduce depth of weep by 1/2 to allow backer rod and sealant to be installed behind front of the flashing.

Crucial detail at weep holes at bottom of A/C sleeves

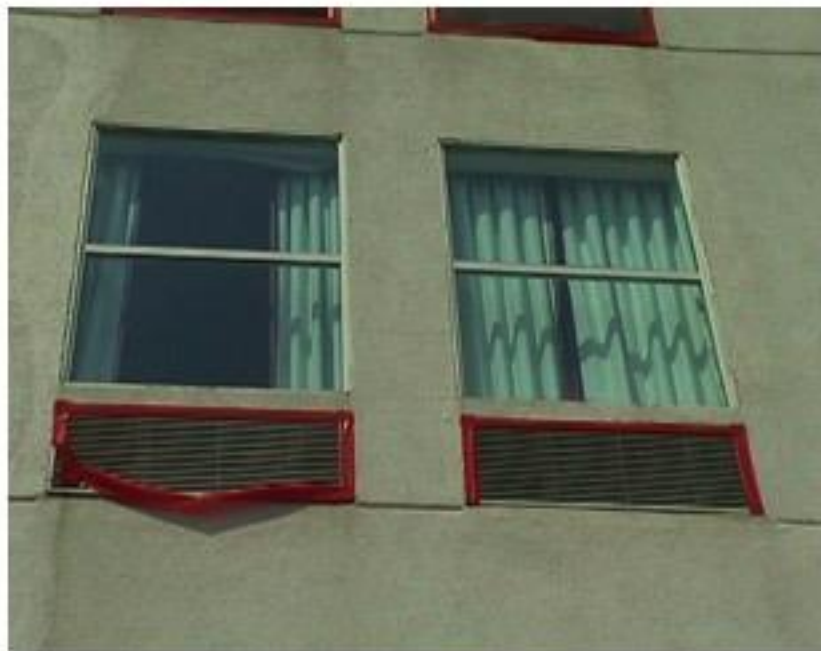
Two A/C problems

The window on the right did not have the new A/C sleeve flashing installed resulting in drainage behind the EIFS

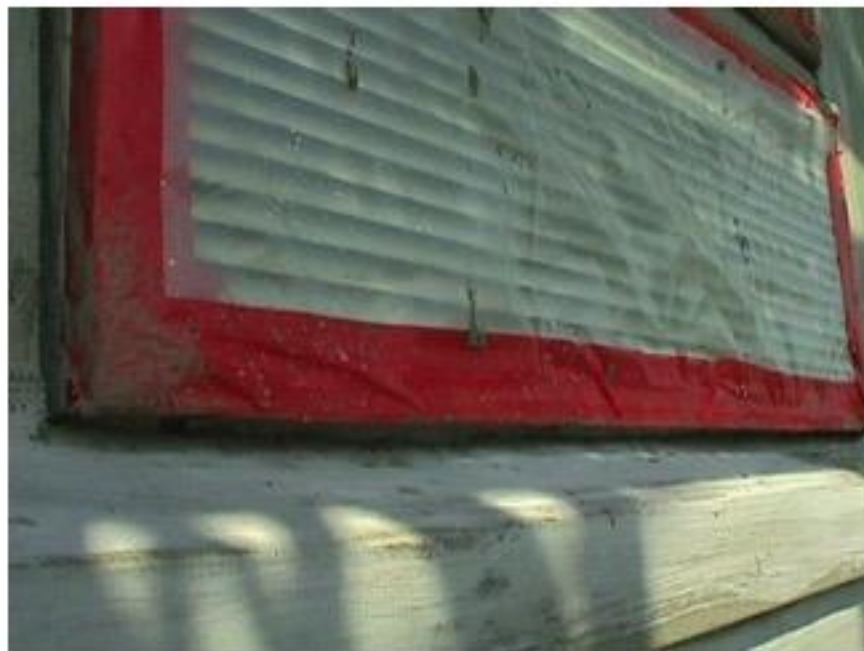
At the second and fifth floor the flat shaped insulation is too flat and the joint is too tight to install the backer rod and sealant

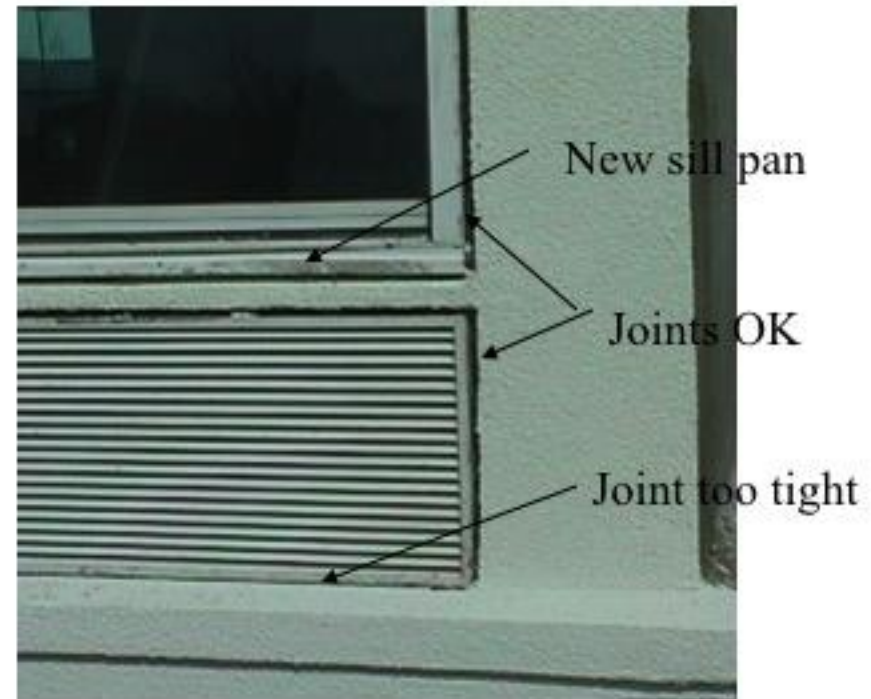
Finished window and A/C unit show new backwrapped joints. A/C sleeve sill too tight to install sealant system

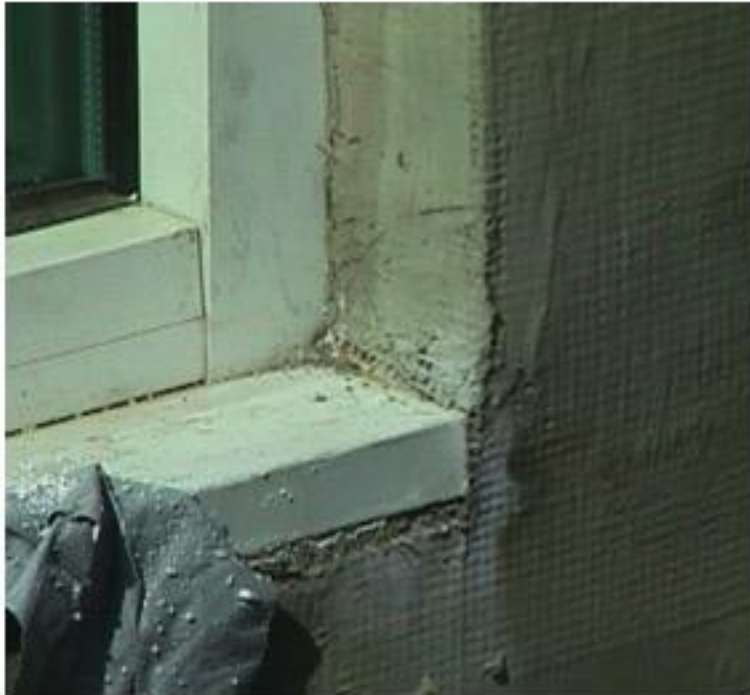
Fixed Glass on 1st Floor

Original sill pan evidences water below sill/jamb corner

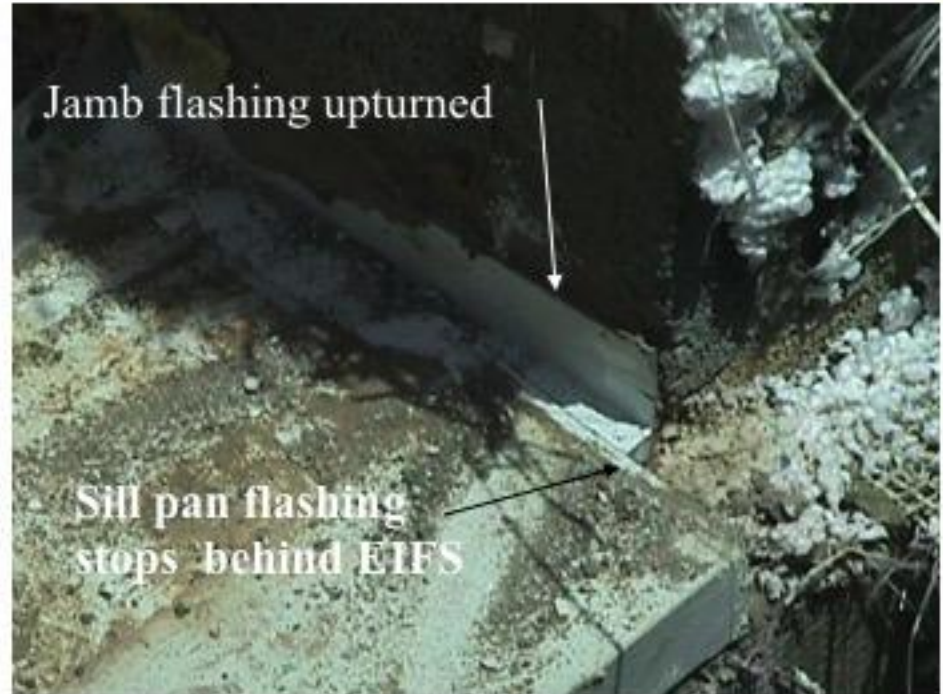
When torn apart the reason is that the jamb upturn stops and deposits all water in pan behind EIFS.

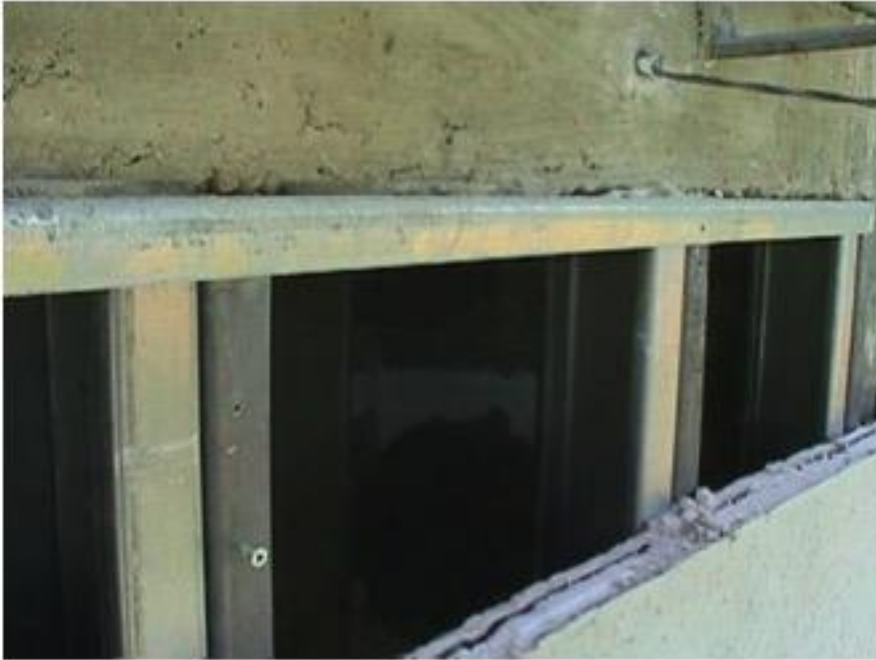
Framing Issues

Note no fasteners between studs and track. Also there were too few fasteners in sheathing. Bright studs are new studs to achieve wind load capacity.

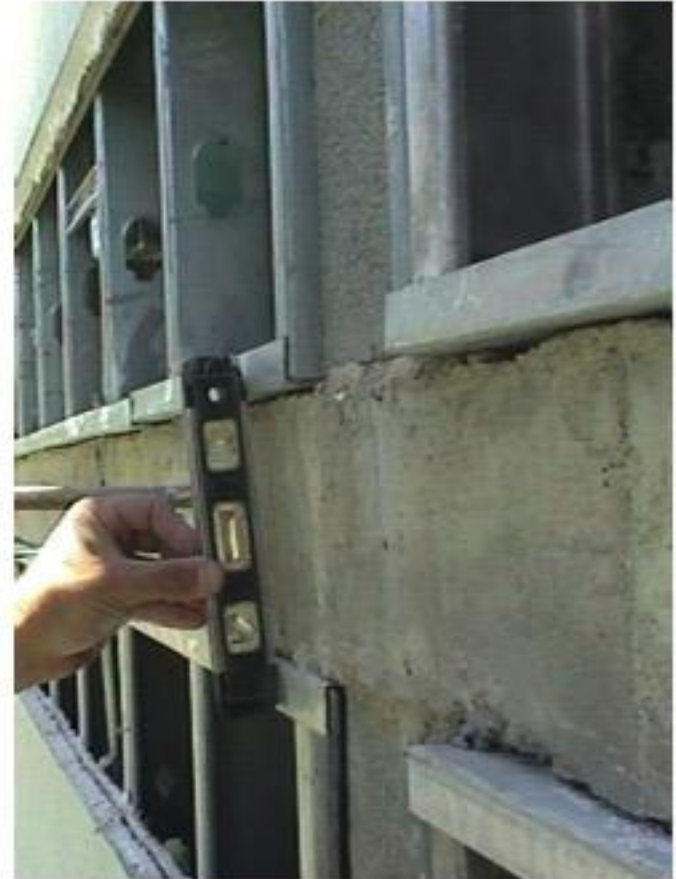
The framing on the exterior walls is very poor.

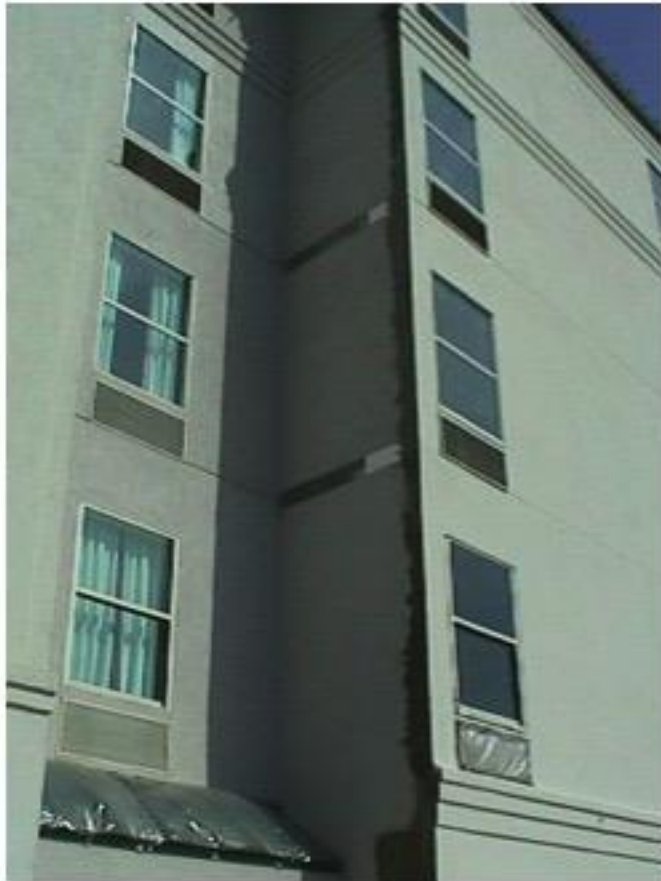
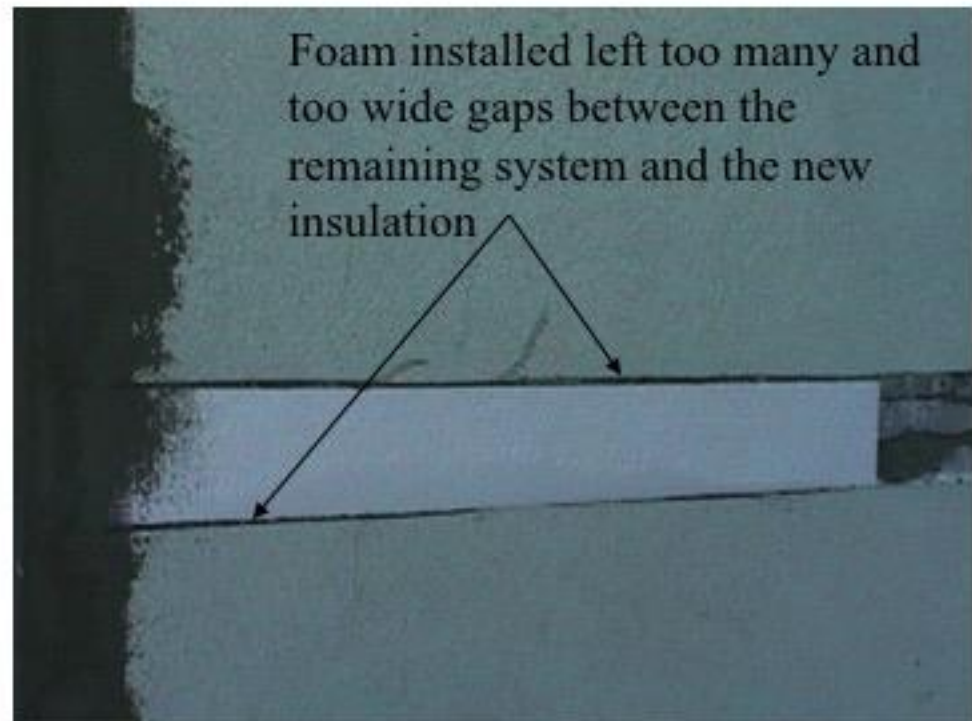
Floor Line Reconstruction

Floor line grooves are too deep. They were cut out 12" and new foam, base coat, and finish was installed.

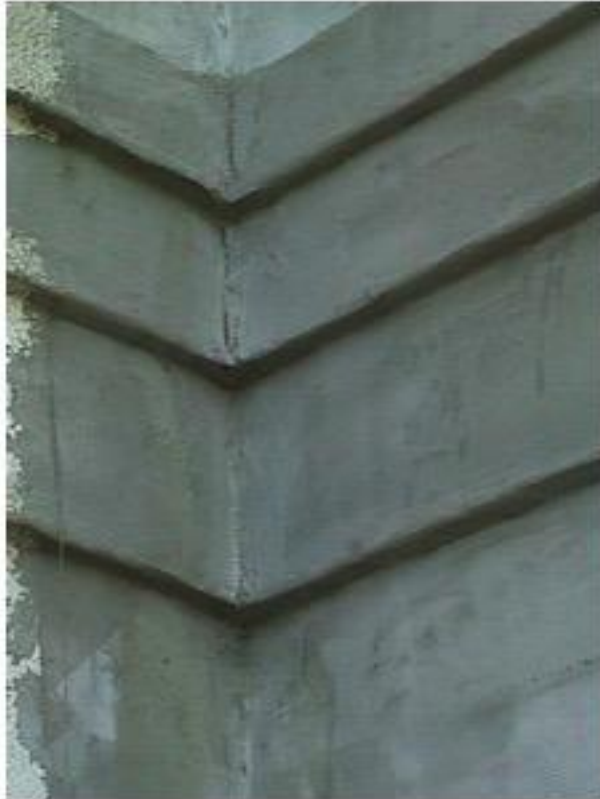
Miscellaneous Details

Very rough corner joint with fabric bridged and gaps in base coat.

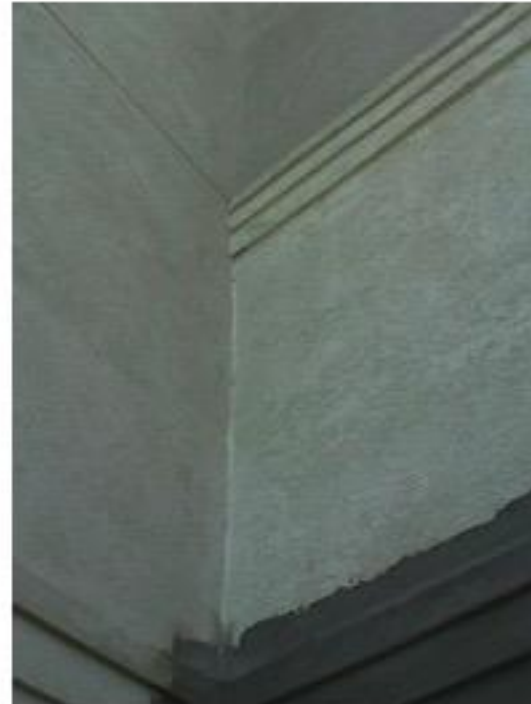
This is a finished corner. The wall on the left is a frame wall and the wall on the right is concrete block. There should be a joint in the corner. There is a crack there now.

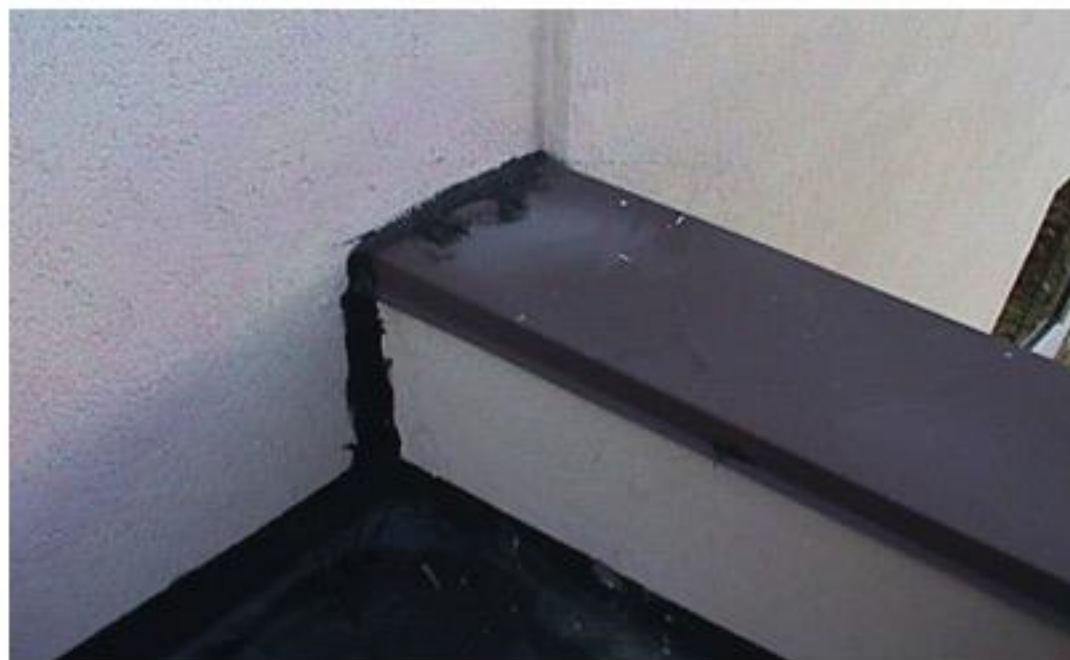
Roof Parapet Detail

Parapets are simply ended with no counterflashing.
The cap flashing is caulked to the wall.

Note: This photo is not from this project. But this condition did occur 8 times!
