QC Inspection

EDI

Nov. 2012

FIELD REPORT

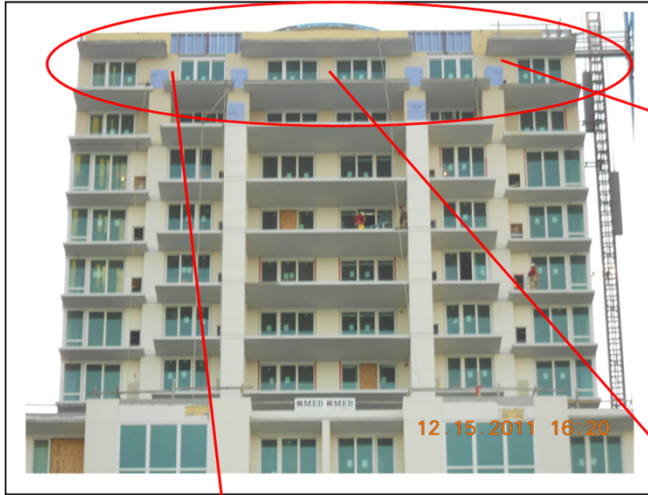
5 East 18th floor

East Elevation Finish Coat

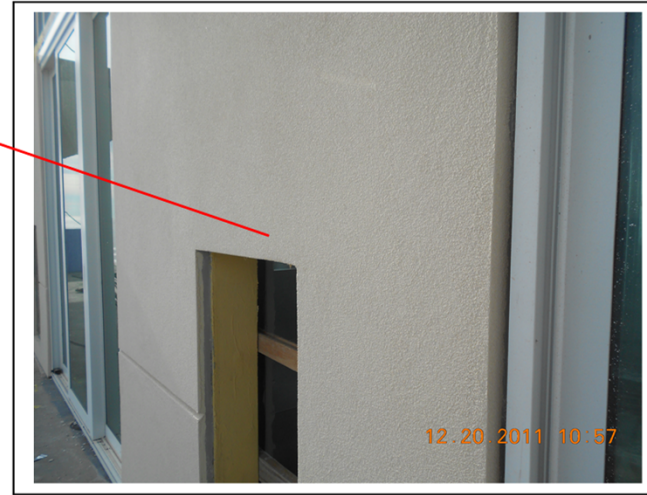
6 18th floor finish coat ok

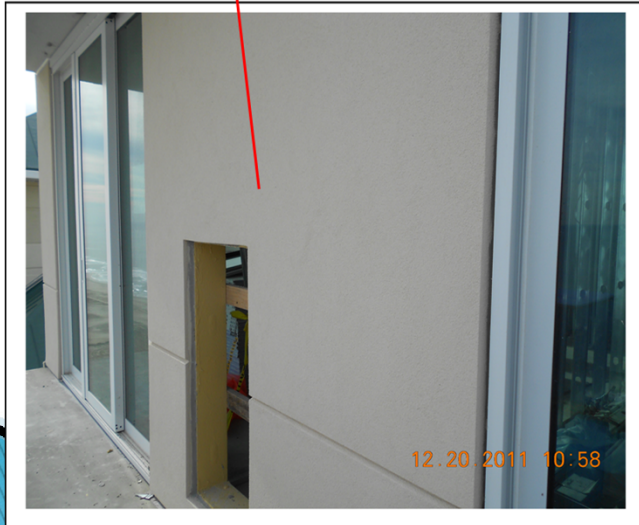
7 18th floor finish coat ok

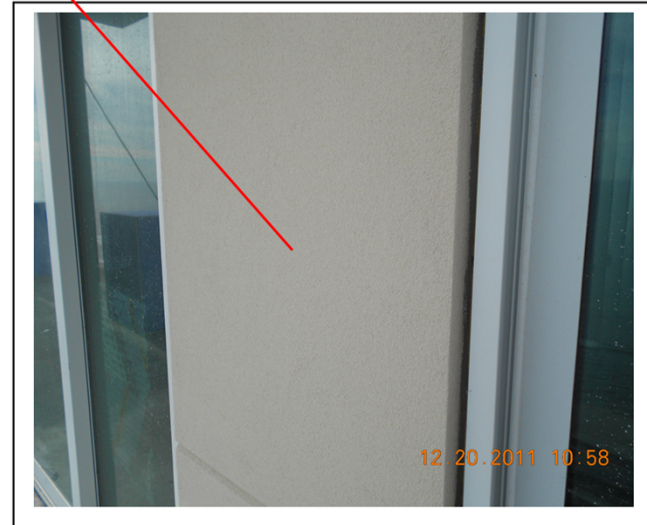
8 18th floor finish coat ok

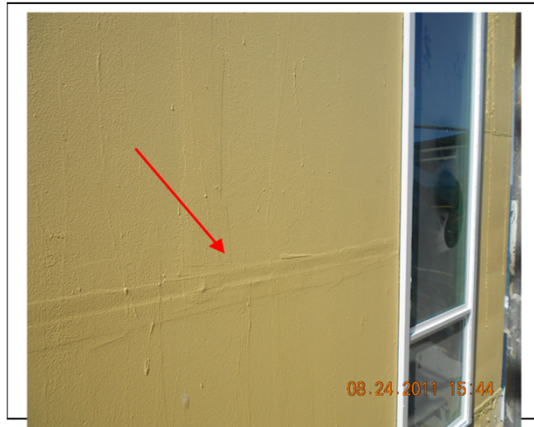
1 East meshed Gyp jt.

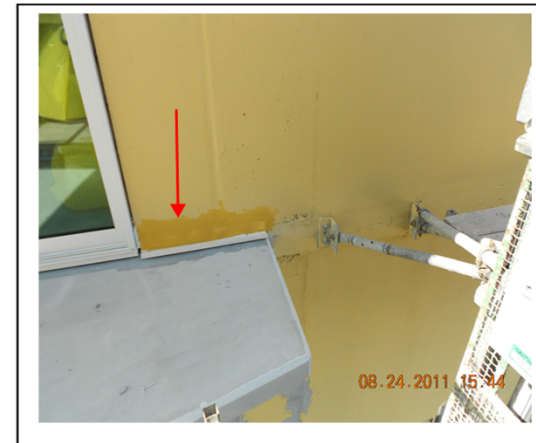
2 East repaired gold coat at bal.

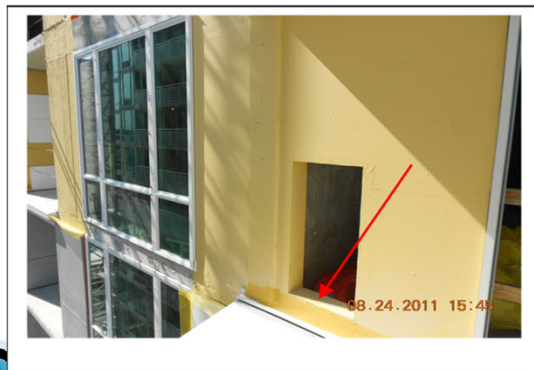
3 VTAC Does sill get pitched?

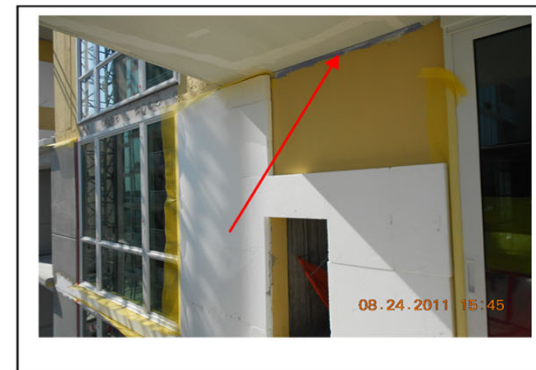
4 Bring Gold Coat to top

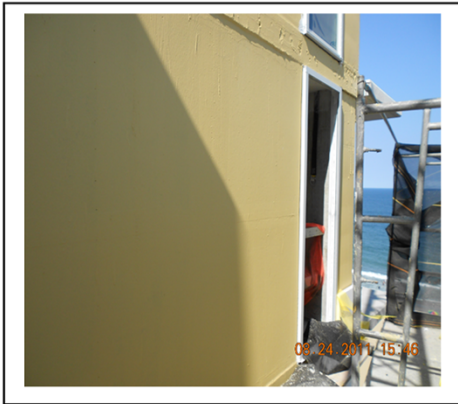
5 East - Gold Coat OK

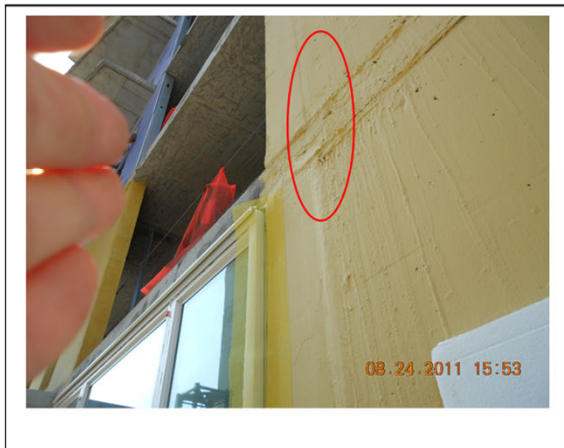
7 Mid point frame to slab

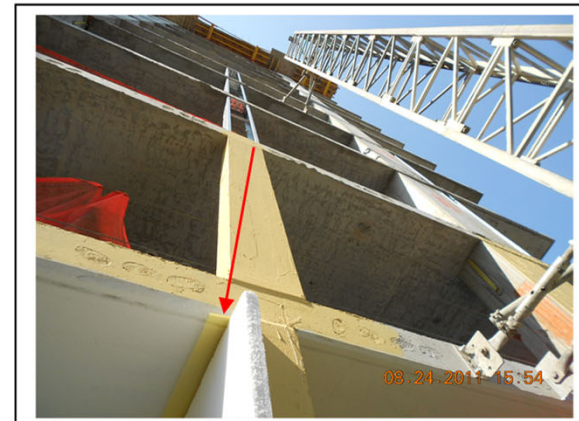
8 mid point – Backwrap OK

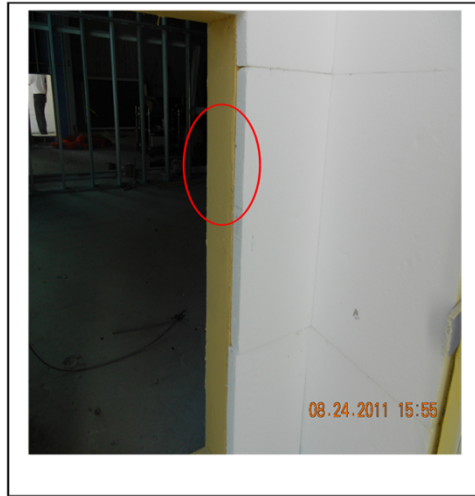
9 S-West gold covers stud opening

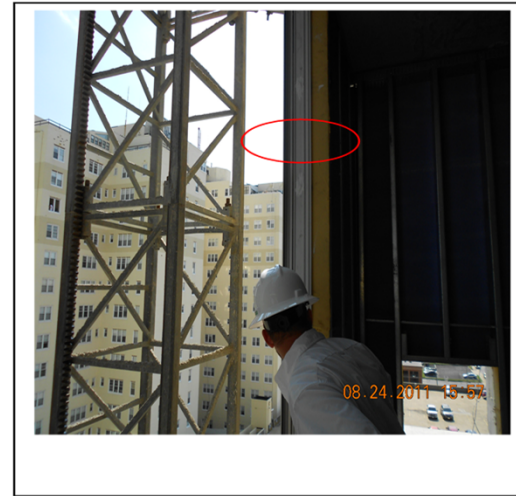
10 west gold covers stud opening
