Sealants

OC110211 SE sealant sample

OC112211 Weeps and Penetrations- General

OC6512 Re-inspection Log

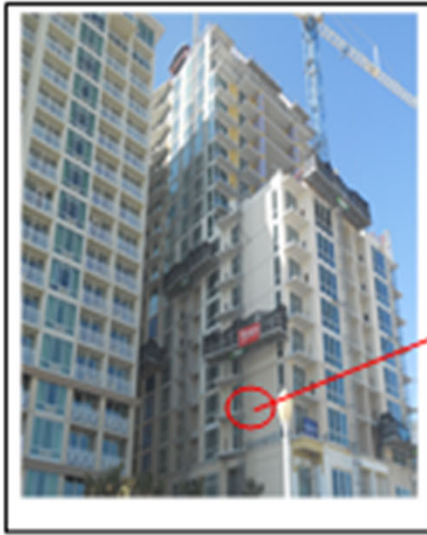
1 South East 4th floor

South Elevation Floor Expansion Joint Sealant Sample

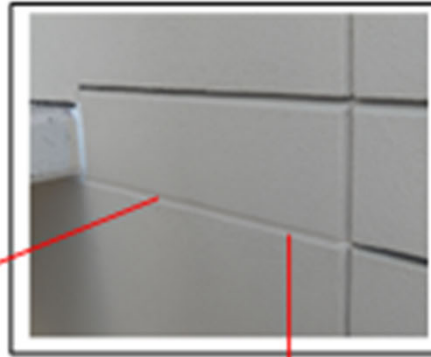
2 4th floor joint sealant

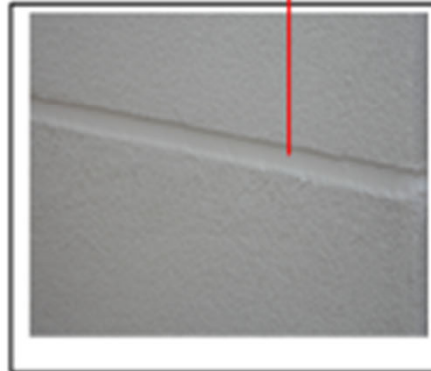
3 4th floor joint sealant

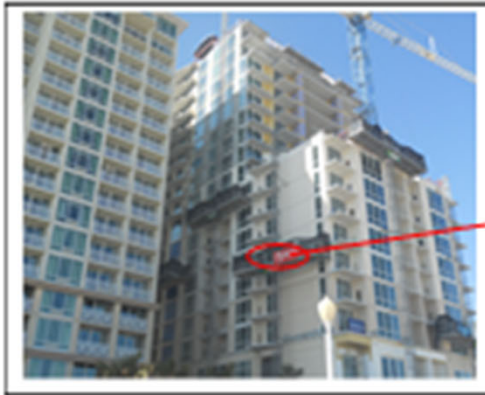
4 South East 6th floor

South Elevation Floor Expansion Joint Sealant Sample

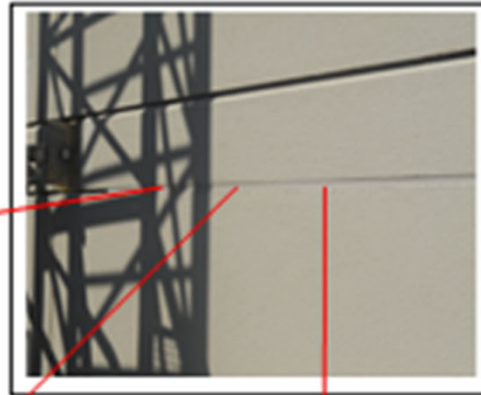
5 6th floor joint sealant

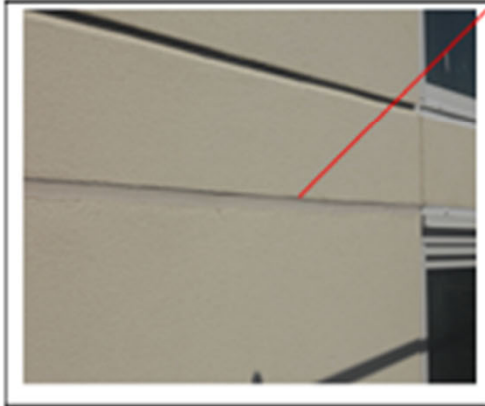
6 6th floor joint sealant

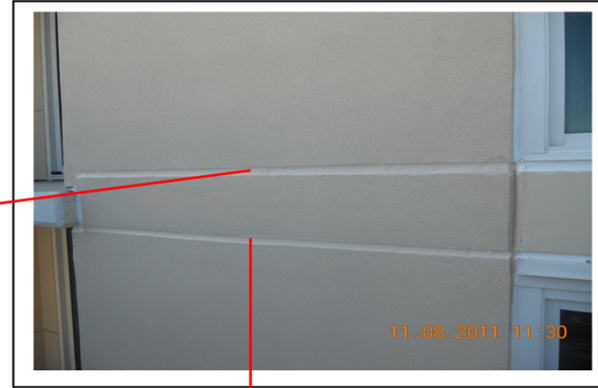
8 Item #014 no weeps Before 11.7.11

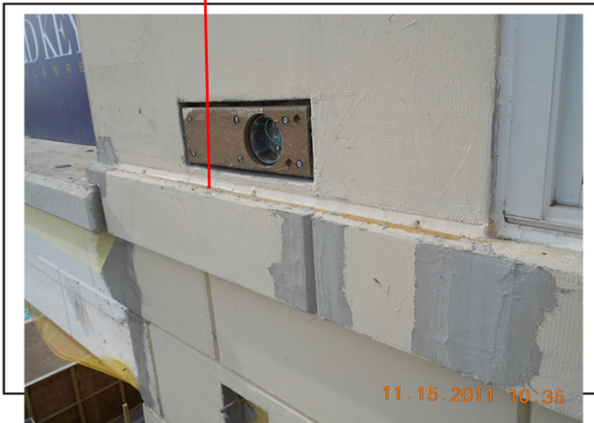
9 Item #014 w. weeps After 11.15.11

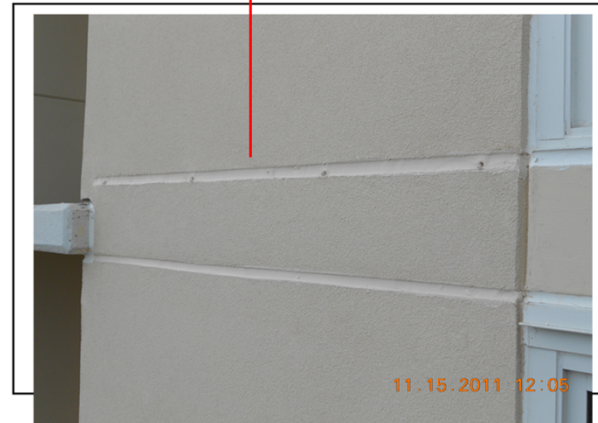
10 Item #014 w. weeps After 11.15.11

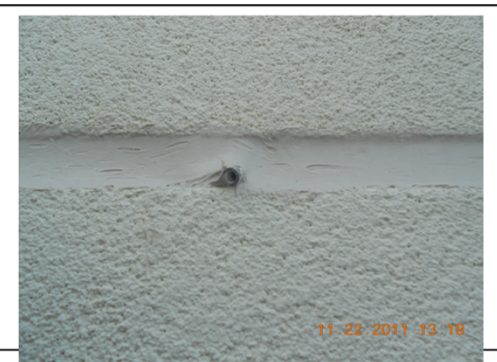
Weep holes were checked during inspection. Random photos show open ends.

1 weep hole with open end

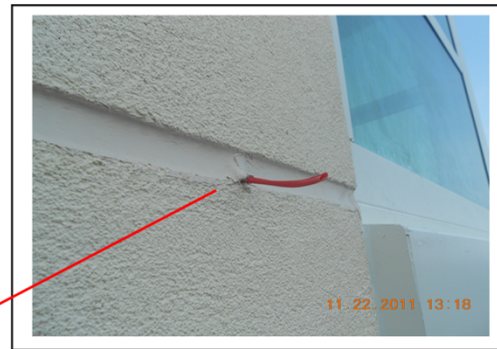
2 weep hole with open end

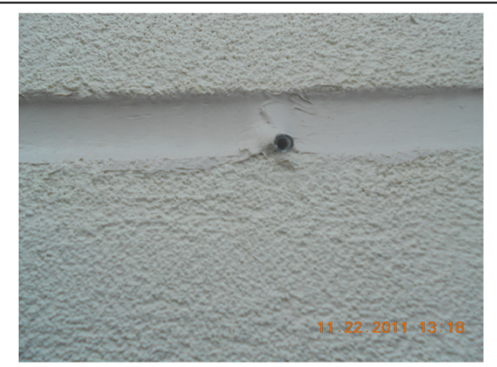
Piece of wire inserted in the weep hole to show open ends

3 weep hole with open end

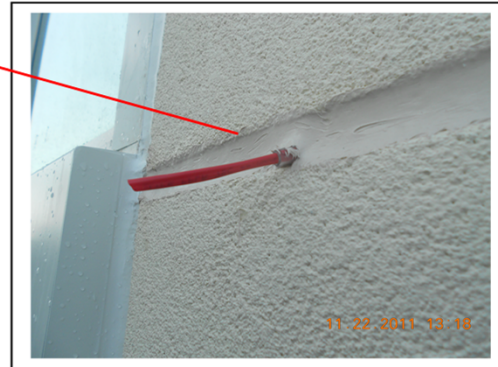
4 weep hole with open end

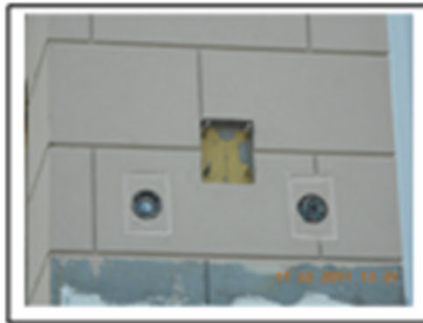
5 Item#015 penetrations in progress

These penetrations should be back-wrapped with a 1/2 inch isolation joint sealed at substrate and backer rod and sealant at the face.

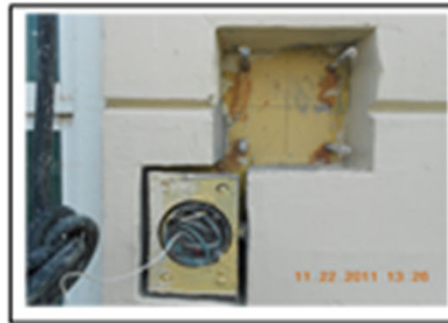
6 Item#015 penetrations in progress

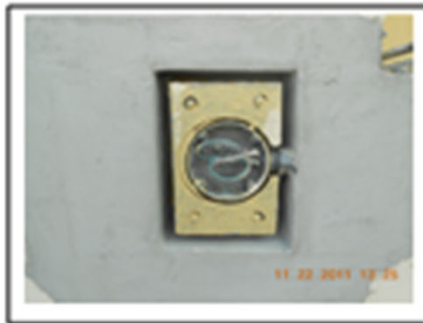
7 Item#015 penetration in progress

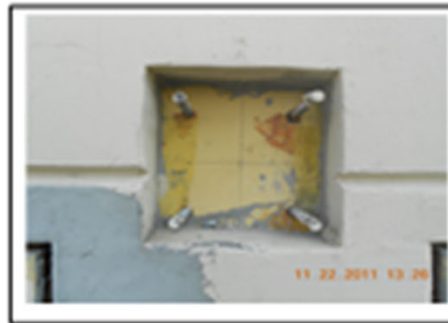
8 Item#015 penetration in progress
