Field Testing

PROJECT:	OCB III	DATE:	10.31.11
PROJECT#	10.023-17c	CONTRACTOR:	MEB
WEATHER:	61 clear	INSPECTOR:	JR/rtl

OC103111 E9 water test

East Elevation Water Test

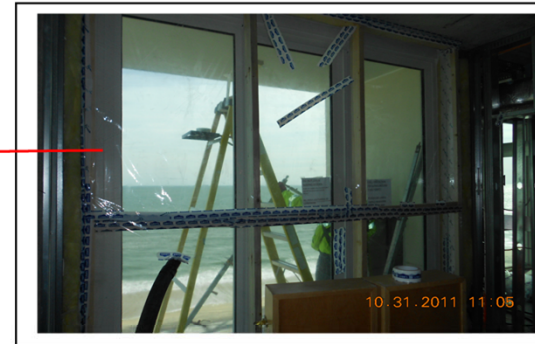
2 9th floor slider water test

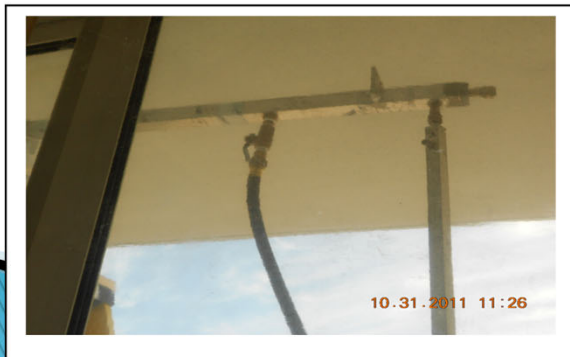
3 9th floor slider water test

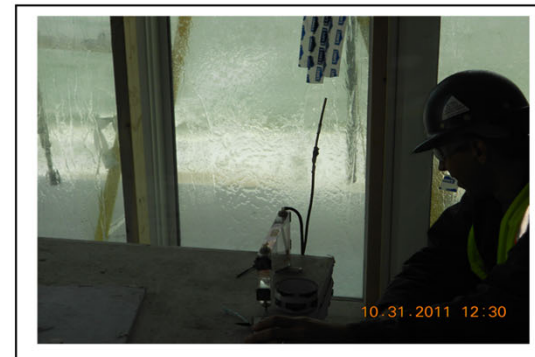
4 9th floor slider water test

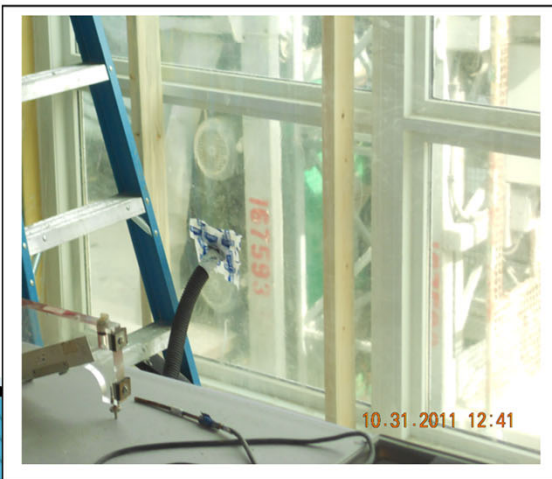
7 9th floor window water test

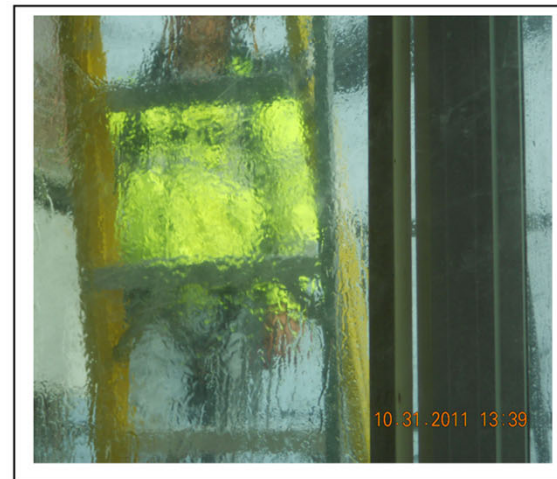
8 9th floor window water test

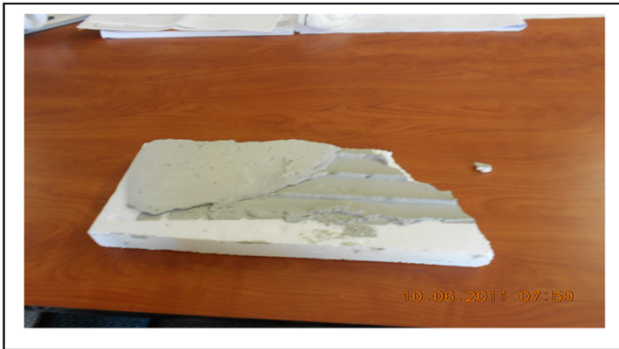
1 10th floor

Piece of EPS from 10th floor showing an excessive amount of adhesive which may block the drainage plane.

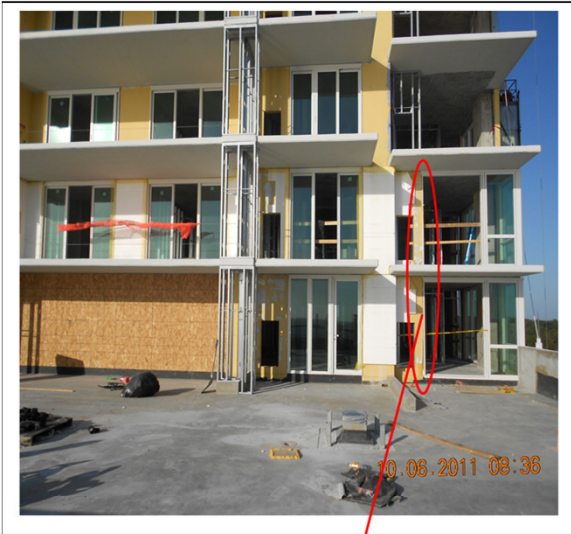
3 10th floor

Framing at window jambs were moved. Mesh and Gold Fill has to be reinstalled.

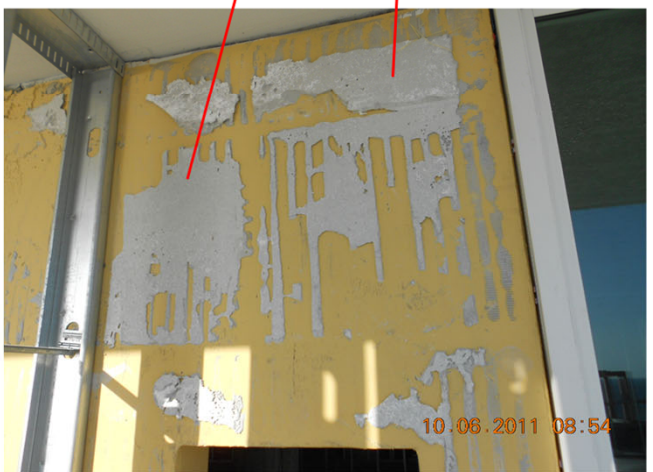
6 10th floor WT 001

Photo showing excessive amount of adhesive on the substrate.

Water tests will be conducted this week to evaluate the effectiveness of the drainage plane in areas of built up adhesive. If an area fails the water test it will be assigned a re-inspection number, then re-inspected when corrected.

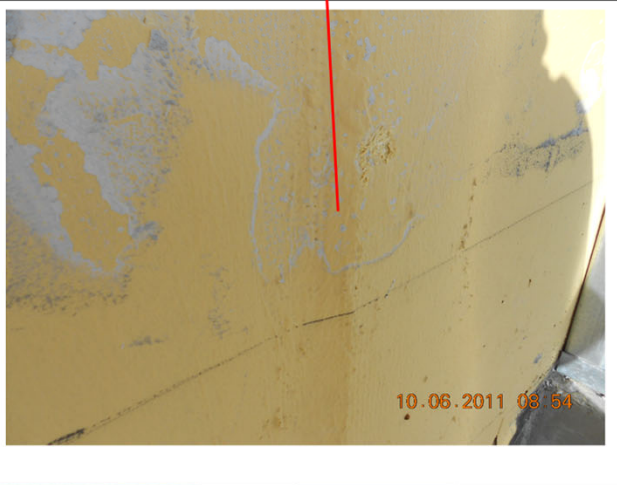
8 10th floor

Substrate out of plane. This does not meet STO specifications of 1/4" in 8'. Wall will have to be build out with EPS or one coat stucco to meet planar surface tolerences.

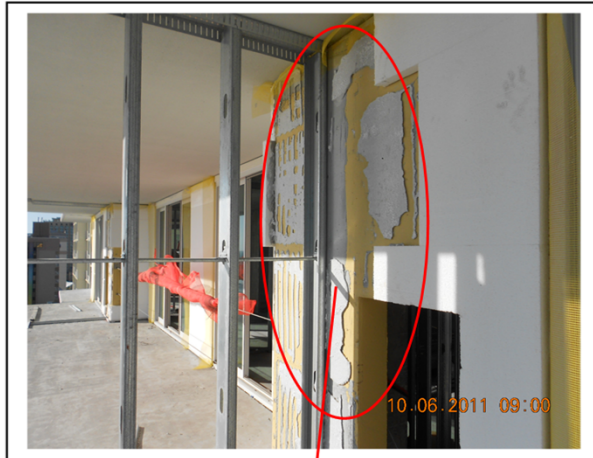
9 11th floor WT 002

One Coat Stucco at uneven surfaces

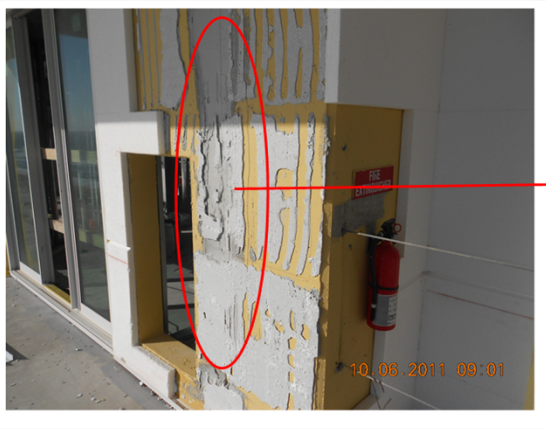
11 11th floor WT 003

One Coat Stucco at uneven surface

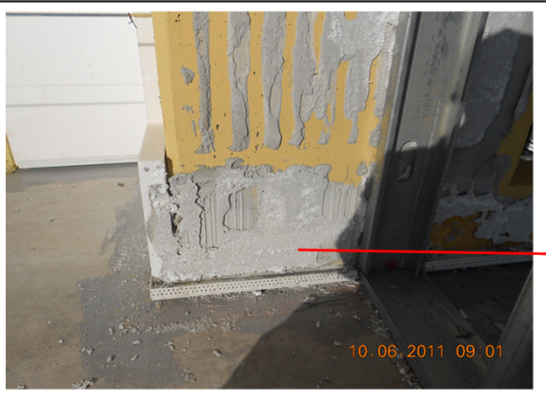
12 11th floor WT 004

Excessive amount of adhesive may be blocking drainage plane

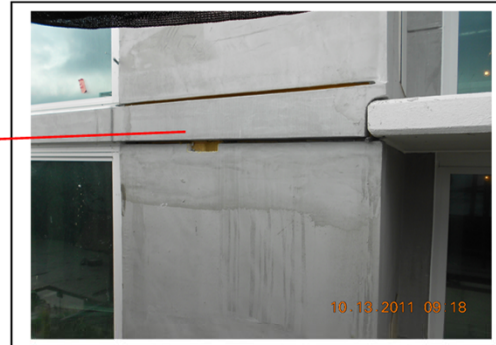
2 4th floor EPS cut to perform test

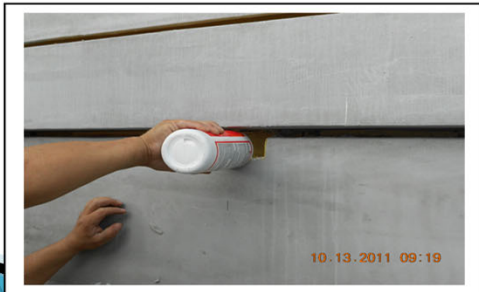
3 4th floor water poured behind EPS

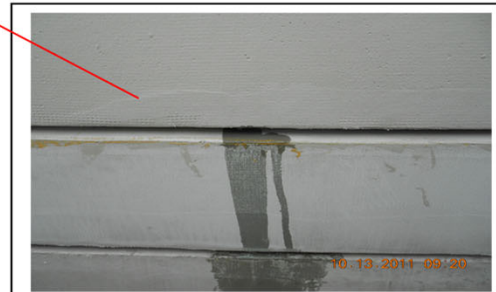
4 4th floor water at joint below ok

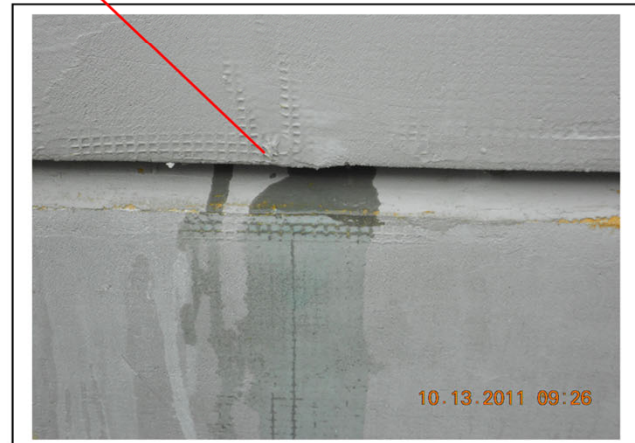
8 8th floor water at joint below ok

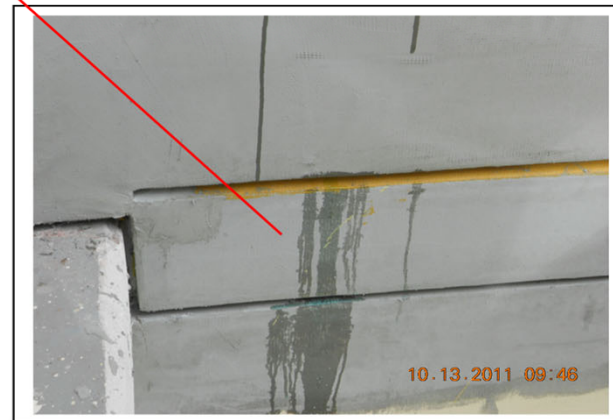
12 4th floor water at joint below ok

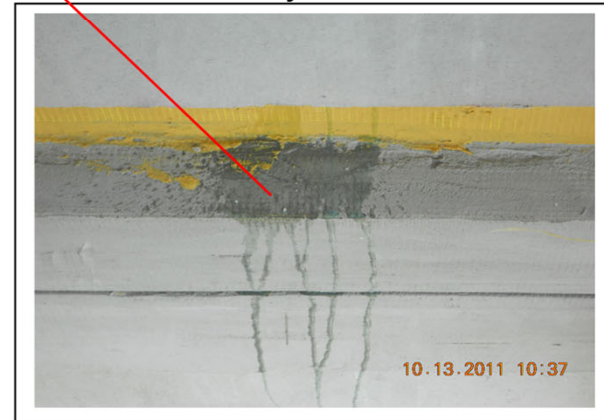
16 11th floor water at joint below ok

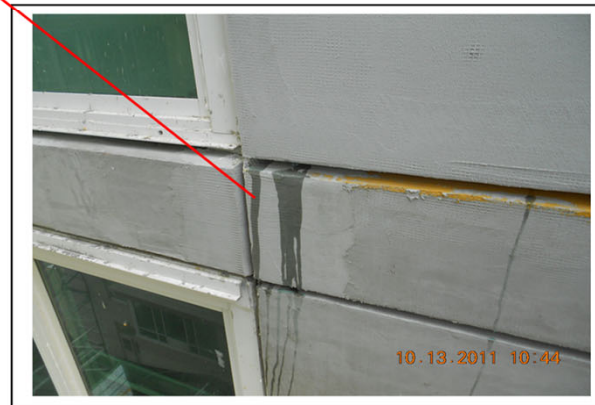
20 6th floor water at joint below ok

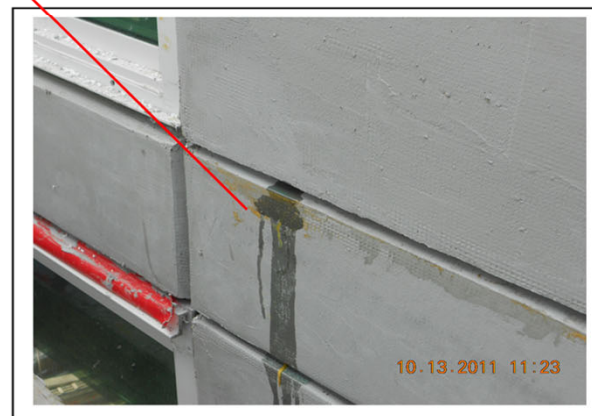
24 6th floor water at joint below ok
